Final Report
October 25, 2013

**Facility Assessment:
Michael V. DiSalle
Government Center**

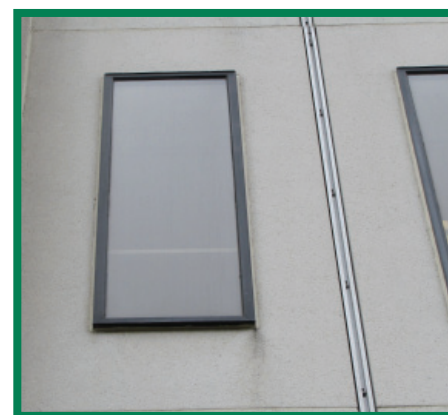
The vision glazing infills in the punched opening windows are composed of a one inch thick hermetically sealed insulating glass unit (IGU) (Photos A-01 and A-02). There were no signs of fogging or other signs of hermetic seal failure. Using a hand-held detector did not detect a metallic low-E coating, which is not expected for a glazed wall constructed in 1983. From the exterior scaffold, exterior glass surfaces appeared to be in exceptionally good condition. This was probably because of frequent cleaning since the building was completed, however some surface staining on the glass surface was noted and has likely began to evolve since the two year layoff in exterior cleaning.

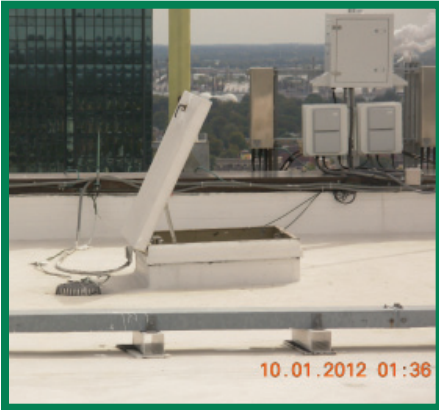
A-31

The roof hatch to the penthouse is within six feet of the roof edge (Photo A-31) and should have a guardrail for fall protection. Several manufacturers produce roof hatch rails with swing gates that connect to existing hatch curbs that are OSHA-complaint.

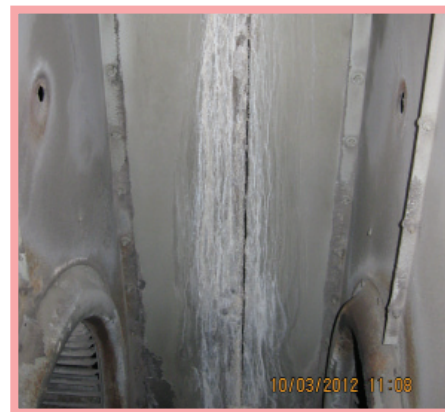
M-003

Cooling tower spray distribution parts were replaced in 2007. There is surface corrosion, discoloration and streaking of the tower casing consistent with leakage (Photos M-002 and M-003). There is also evidence of leakage onto ductwork, piping and equipment (Photo M-004) located under the cooling towers, as well as plastic sheeting in place to shed any leakage (Photo M-005). Note that one tower was operating when the survey was done and there was no water leakage occurring at the time. There were a couple closure panels

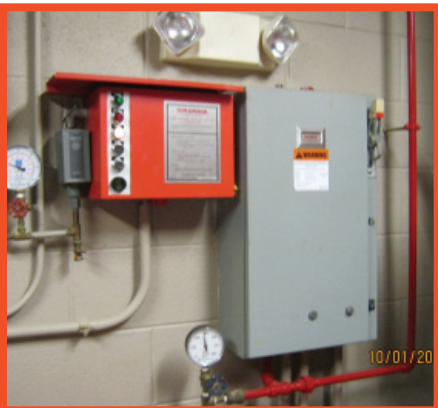
FP-8

plexGrinnell test/inspection report dated September 18, 2012 indicates that seven gauges in the Fire Pump Room appear to be due for replacement per NFPA 25.
