**NIOSH**  
Fire Fighter Fatality Investigation  
and Prevention Program

A summary of a NIOSH fire fighter fatality investigation

April 14, 2015

## Two Career Fire Fighters Die in a Rapid Fire Progression While Searching for Tenants—Ohio

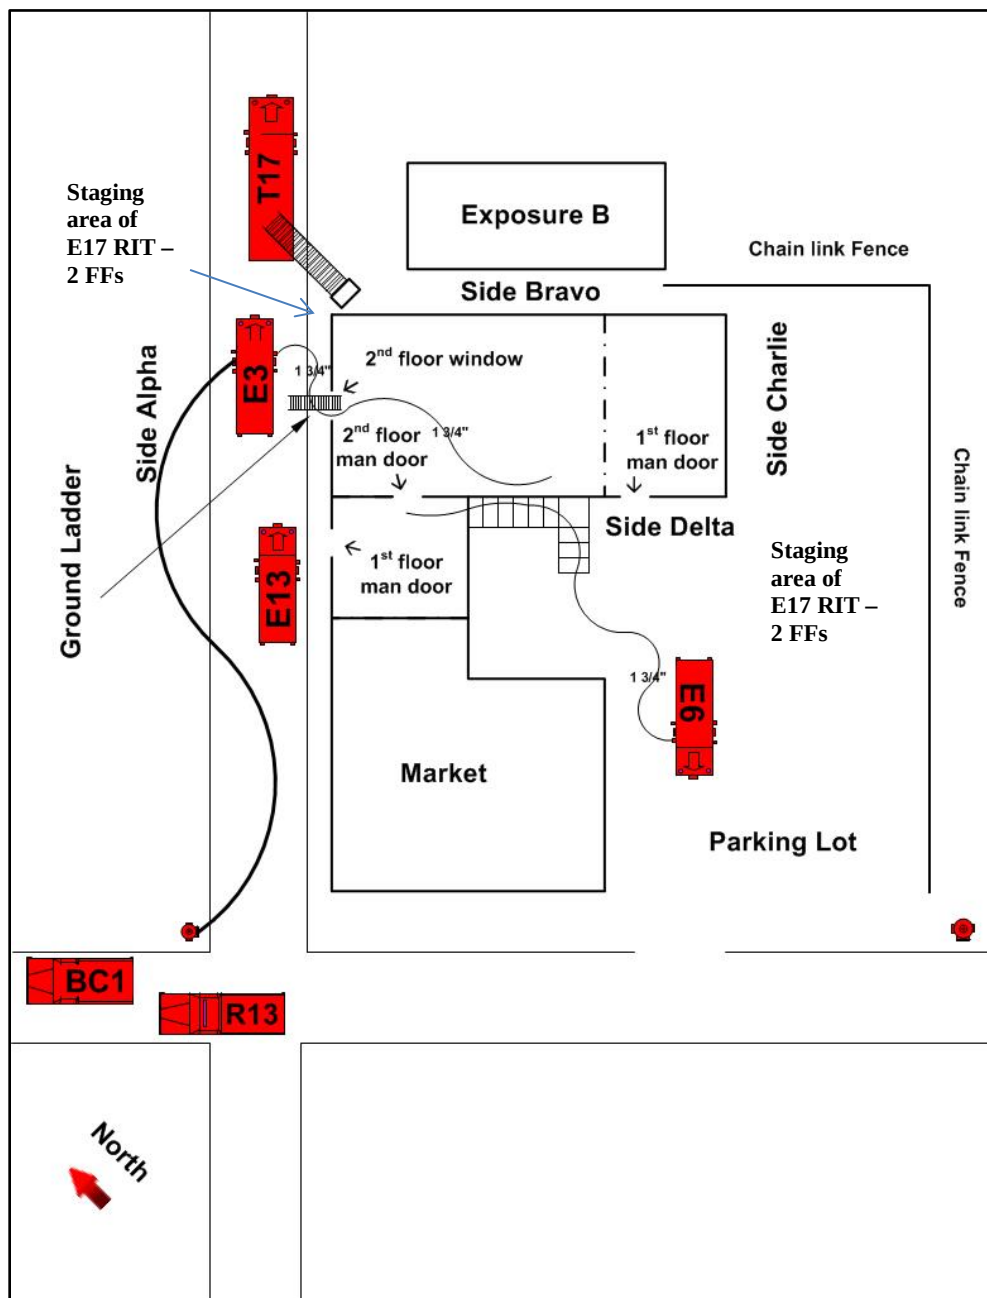
assigned search with Rescue 13 (see Diagram 4). *Note: Command was informed by an occupant at the scene that all occupants were out of their apartment but there was a dog on the second floor.* Engine 13 opened a first-floor Side Alpha apartment man-door on the Delta exposure of the garage.

**Diagram 4. Initial apparatus placement and hoseline deployment of the first alarm companies.**

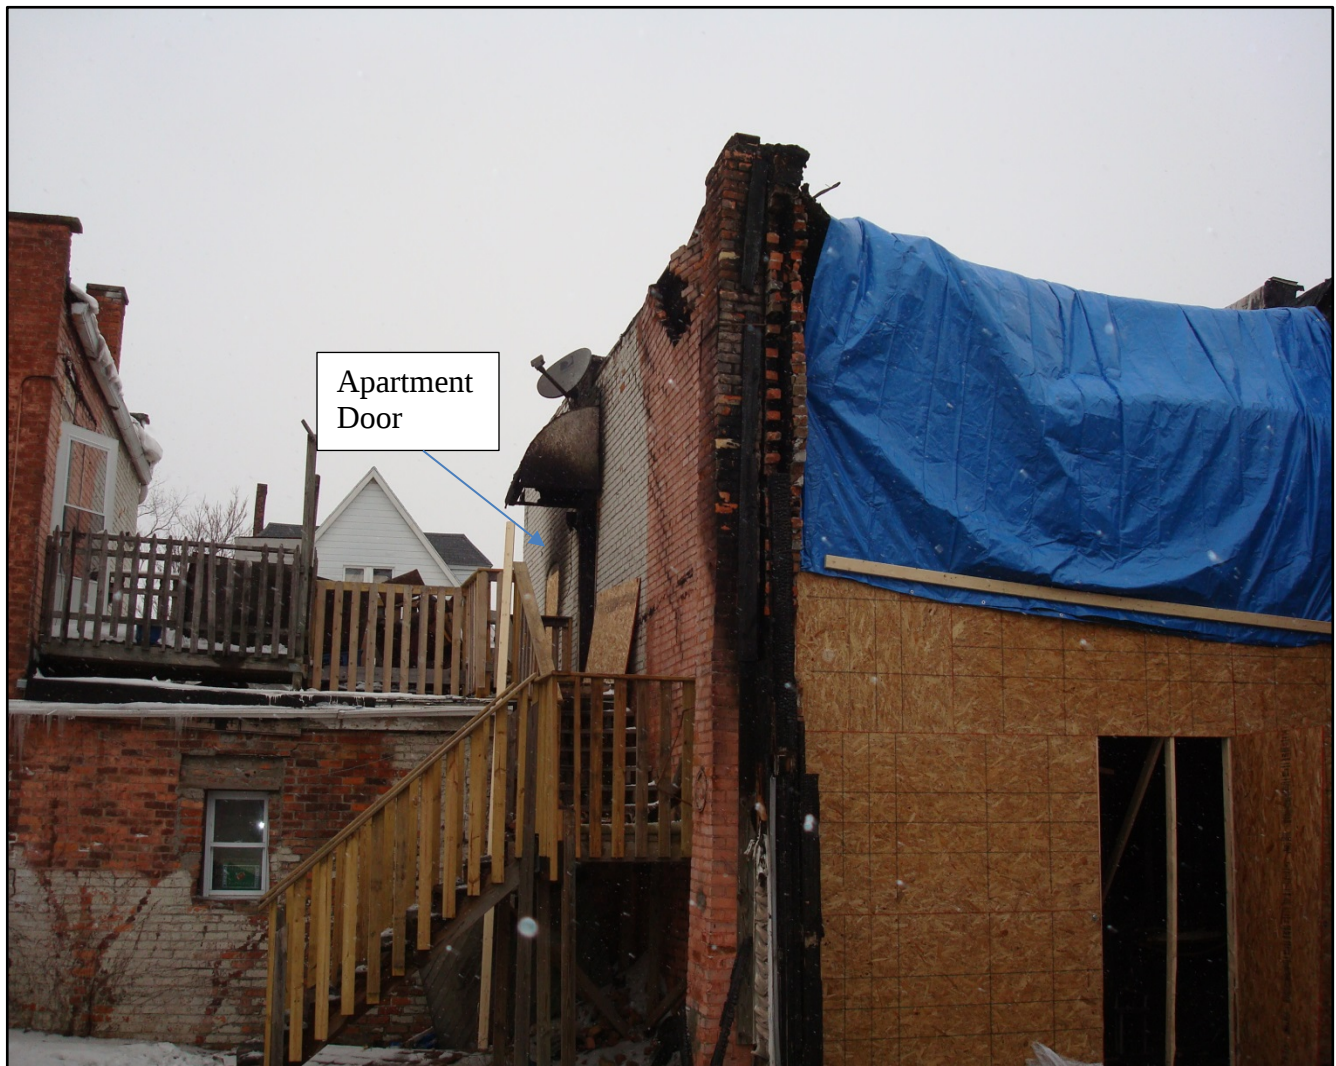
**Photo 3. Exterior stairs to Side Delta man-door to second-floor apartment that Engine 6 entered.**  
***(NIOSH Photo)***

The acting officer and fire fighter from Engine 6 made entry into the second-floor apartment. Once inside the doorway, Engine 6 turned to the right along the Side Delta wall just as the two fire fighters from Engine 3 went by them. The Engine 6 crew went along the Side Delta wall about 8–10 feet. They stated they didn't feel much heat but visibility was zero. The Engine 6 acting officer held on to the fire

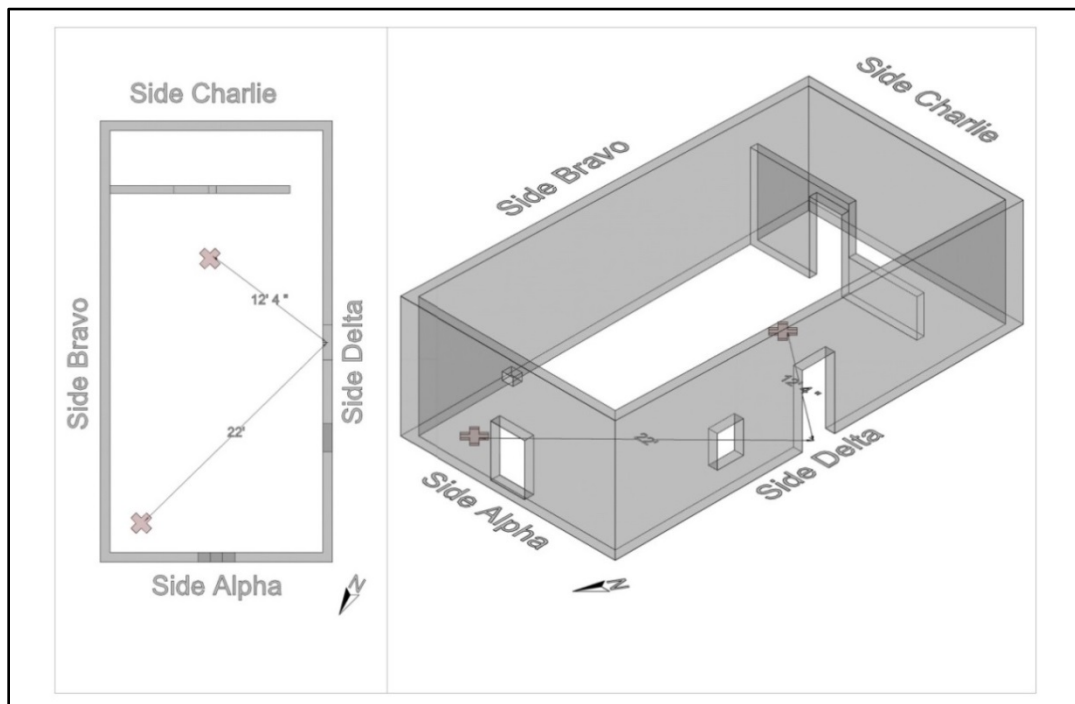
At approximately 1517 hours, Engine 7 notified Command that they had found a downed fire fighter (Fire Fighter #1). They exited the Side Delta man-door carrying the fire fighter down the stairs to Life Squad 1 in the rear parking lot. The Engine 7 and Engine 17 RITs re-entered the second floor to continue searching for Fire Fighter #2.

**Diagram 5. Approximate locations of the two fallen fire fighters on the second floor of the fire structure. Fire fighter #1, which was located first, was found near the Alpha/Bravo corner. Fire fighter #2 was found closest to the Side Delta man door.**  
(Diagram courtesy of the city's Engineering Services.)
