Final Report
October 25, 2013

**Facility Assessment:
Michael V. DiSalle
Government Center**

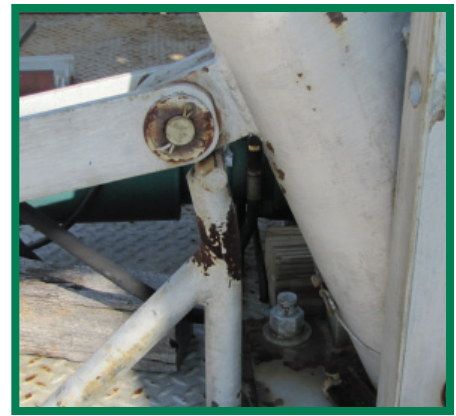
A-35

Since it is stored in a weather vulnerable location, the portable façade access equipment appears to show signs of deterioration from the degrading elements.

The entire façade access unit should be inspected, serviced as necessary, and certified for use in accordance with governing codes, ordinances and regulations. There were visual signs of material distress at the mast connection and pivot points. These should be inspected by a professional engineer before the equipment is re-deployed.

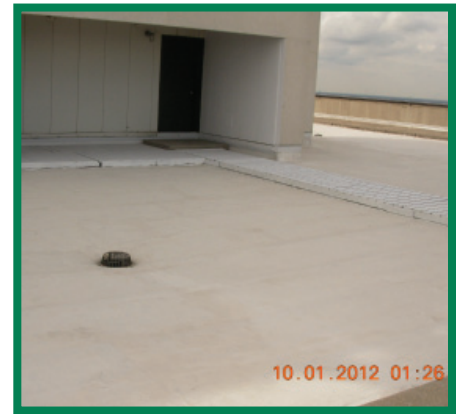
A-27

The new roof system appeared to be in excellent condition. The sheet metal copings with EPDM tape at the joints appeared to be in good condition, although they appeared to be older than 2011. Roof drainage appeared to be adequate and drains were working properly. The roof flashing at the vertical parapet walls appear to be in good condition.

The main roof should be routinely inspected at least twice a year (early Spring and late Fall) and after any notable weather events. Preventative repairs should be made when noted. Roof drains should be checked to ensure proper drainage.

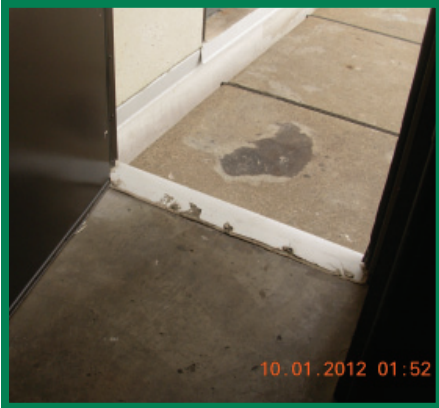
The door leading to the main roof leaks when it rains. The door should have a threshold, weatherstripping and a drip strip (at the head of the door frame) (Photos A-32 and A-33).

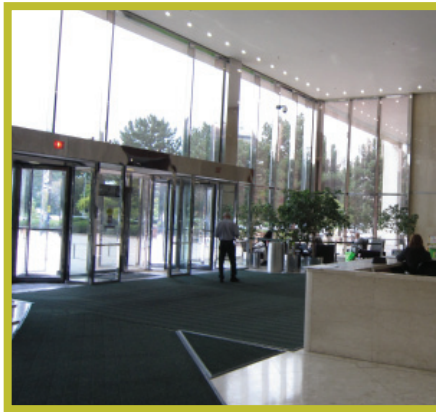
I-9

Lobby glazing and frames are in good condition with no visible signs of leaking (Photo I-8). Revolving doors operate smoothly and seals are performing well. "EXIT" sign above one of the revolving doors is not illuminated (Photo I-9). The ADA door is functioning properly. Upper-level aluminum frames and sills are generally in good shape with no broken panes of glass and no failed glazing seals (Photo I-10). A few windows were previously marked with a taped "X" indicating that a repair was required (Photo I-11). In many instances, the existing drapery track has been removed or relocated and the drywall soffit not repaired (Photo I-12). There is evidence on several windows of glazing gaskets falling out of the frame (Photo I-13). There are several instances of missing rubber wall base at the floor (Photo

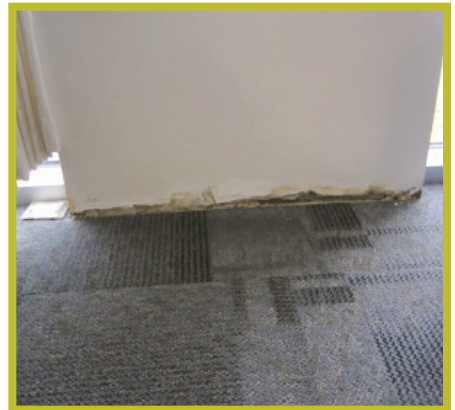
I-14

I-14). Many locations show evidence of water damage. Windows were resealed and repairs made to drywall jamb and head conditions. Level of finish on these repairs varies from poor to very good.

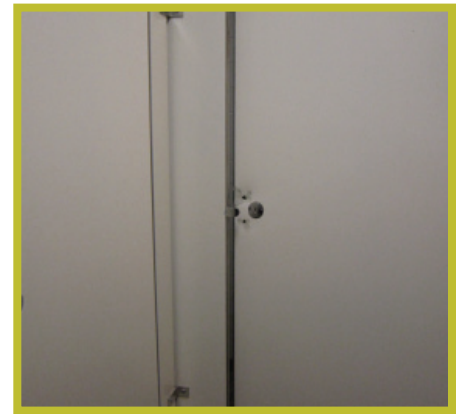
I-30

Restrooms are generally in good condition. All toilet accessories are functioning. Mirrors are in good condition. Toilet partitions are in good condition with only a few instances of hardware that needs attention. (Photo I-30). Piping under the ADA sink is not protected (Photo I-31). Interior vestibule door in Men’s Room is not ADA compliant. An 18-inch maneuvering clearance is required on a front pull side front approach. There are two instances in Men’s Room where mechanical grilles need repair (Photo I-32).

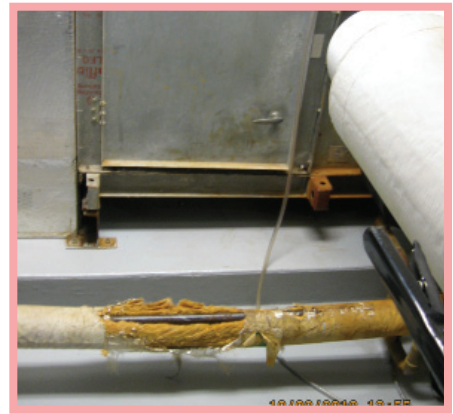
M-001

Some pipe and equipment insulation and jacketing on and around the pumps has been damaged.

Repair damaged piping insulation and jacketing (Photo M-001).

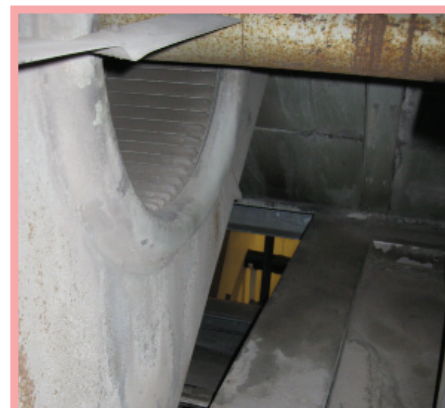
M-006

that isolate the cooling tower from the penthouse mechanical room that were not in place (Photo M-006).

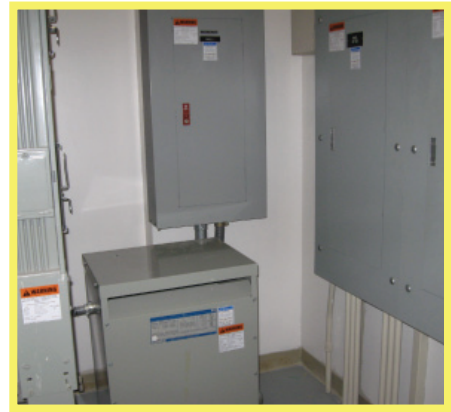
The building has one 2500 ampere feeder bus riser running vertical in west electrical closet with bus plugs for lighting and separate plug for receptacle load with step-down transformer on each floor. As per tenant requests, additional bus plug has been installed where required with a step-down transformer for additional receptacle panel. The base building lighting panels are General Electric 100 ampere at 480Y/277 volt on each floor and provide lighting power through 20 ampere single pole branch circuit breaker on respective floor. Base building receptacle panels are also General Electric 100 ampere at 208Y/120 volt and provide receptacle power through 20 ampere single pole branch circuit breaker on respective floor. Additional sub panels are added as required and these subpanels are mostly Square D, and have been installed on floors required additional breaker space (Photos E-3 and E-4).

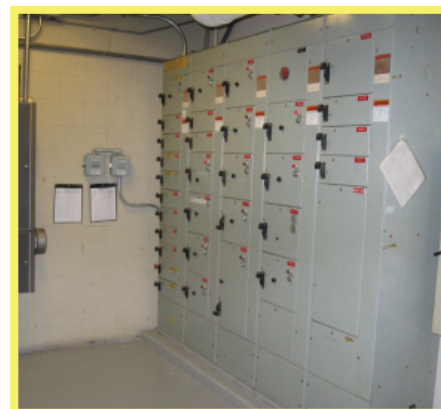
E-5

30-inch spaces and three size one spare combination starters. Another normal power MCC with 1200 ampere main bus and 300 ampere section bus, 480 volt, three phase, three wire to provide power to HVAC equipment on Basement Floor. This MCC has 6-inch space and two size one combination spare starters. There are unused starter for CHWP2, CHWP-4, CWP-2, and CWP-3. The Floor 2 Mechanical Room has a MCC to feed HVAC equipment located on second floor. This is three sections MCC with 600 ampere main bus and 300 ampere section bus and has three size one spare starters (Photo E-5). There is also a MCC on Penthouse floor, which has one spare starter.

All motor control centers (MCCs) are more than 30 years old and parts not available in open market. The MCCs are used as circuit disconnects and starters for HVAC equipment due to use of variable frequency drives or starters provided with mechanical equipment. Reducing the MCC size as required for motor starter only and providing distribution panel for the feeder circuit where MCC have been used as feeder disconnect is recommended.

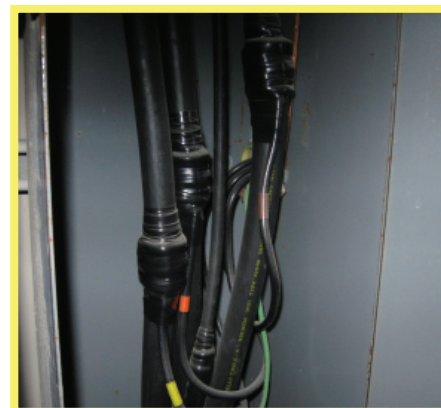
E-6

The building has receptacle power feeder riser running in east electrical closet with tap box on each floor with tap, and transformer with primary disconnect and a 100 ampere, 208Y/120 volt General Electric panel. Panels are good working condition, but it is more than 30 years old and have passed their useful life. Breakers for these panels may not be available in open market (Photo E-6).

The base building power distribution system including distribution panels boards, branch circuit panelboards, power risers are more than 30 years old and passed its useful life span. Replacement of entire power distribution system is recommended. The design engineer should take in consideration that building is using less power than originally designed, and should reduce service entrance gear size, and distribution size as per maximum demand recorded by Toledo Edison.

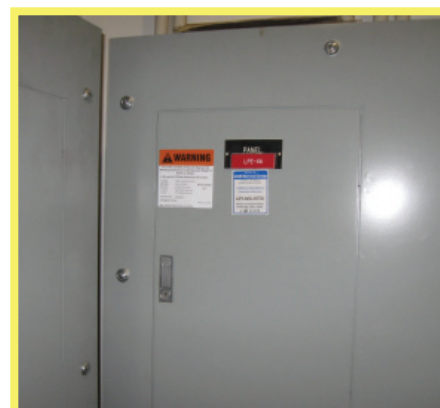
E-16

The building has an emergency/standby power feeder riser running vertically in the west electrical closet with Tap boxes on each floor. Tap boxes have been installed on Floors 4, 8, 13, and 18 with a 100 ampere, 480Y/277 volt General Electric panel to provide power for emergency egress lighting and exit signs through 20 ampere single pole branch circuit breakers. The panels are in good working condition (Photo E-16).

Replace the emergency panelboards located throughout the building.

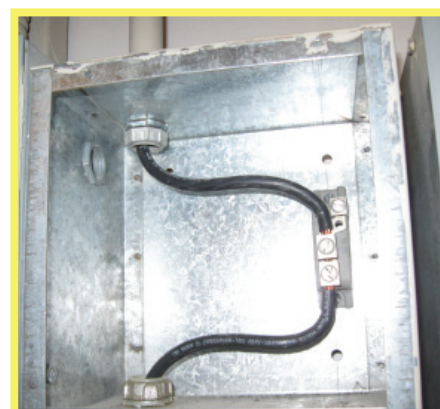
The ground loop is buried and could not be verified during the building walk through. The design drawings indicate that the building is grounded to the loop encircling the building. Building has two #1/0 grounding conductor risers, one in each electrical closet for conversion of normal power panel into isolated ground panel. Each floor has a tap box with isolated ground lugs and some locations have isolated ground termination strips which connect the isolated grounding conductors. This is not a UL listed isolated grounding panel but it does serve the purpose of having an isolated ground. (Photos E-17 and E-18).

Grounding is an essential part of the power and communication systems. To ensure integrity of the grounding, the entire grounding system should be tested every five years using fall of potential method to ensure continuity and that resistance to ground is no more than 5 ohms. Make resistance measurements in dry weather, not less than 48 hours after rainfall. The written report should be kept for records and should indicate measured resistance, corrective measured resistance, and soil conditions at time measurements were made.

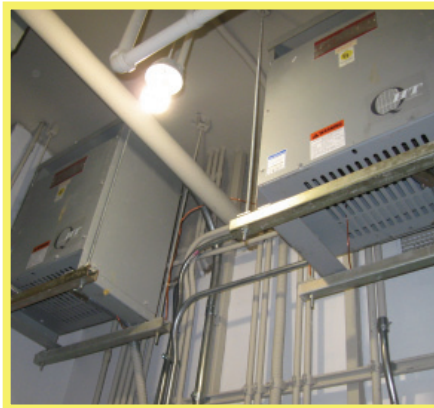
E-26

The Basement, Floor 2 mechanical space and all floors mechanical rooms, electrical rooms, elevator equipment rooms and the Penthouse has T-8 industrial fixtures with electronic ballasts and compact replacement fluorescent lamp installed in incandescent socket (Photos E-25 and E-26).

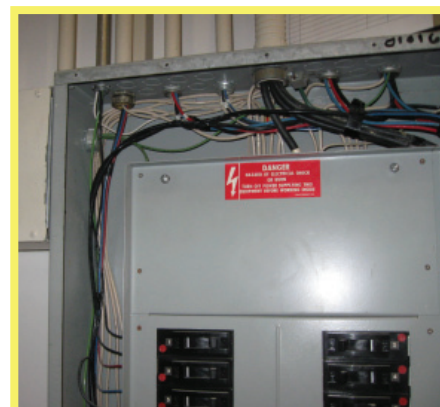
Wiring in building is in good condition and should provide good satisfactory service for an indefinite period of time (Photos E-31 and E-32).

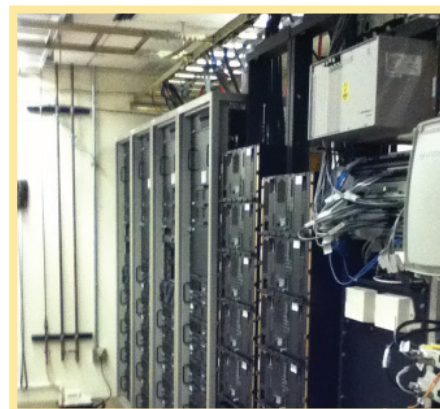
The Equipment Rooms serving Floors 3, 11 and 21 are temperature-controlled, power conditioned, and contain capacity for additional growth (Photo T-1 through T-3).

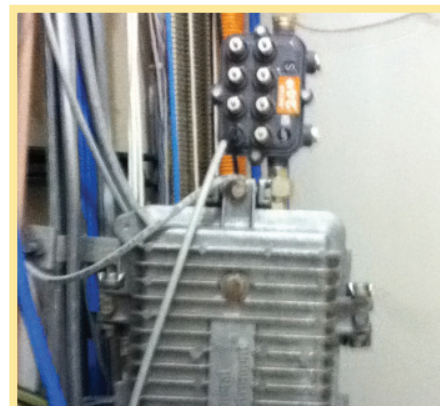
T-4

- Vertical pathway system of 4-inch conduits with growth capacity
- 100 pair copper backbone terminated on 66 type blocks
- One (min) quad electrical receptacle
- Multiple Horizontal conduits leading into the tenant ceiling space
- Coax RF Antenna extending to Floor 22
- CATV with minimum 8 port taps and amplifiers (Photo T-4)
- The closets are not climate controlled, active equipment is not recommended for these areas

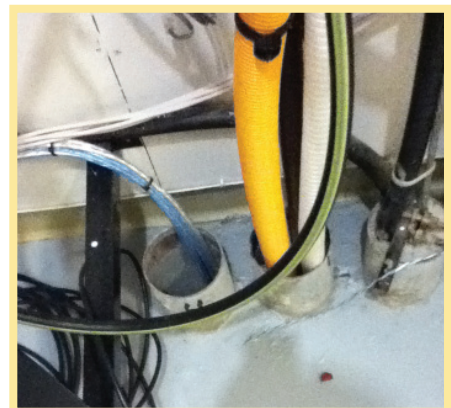
T-7

Consistency of firestopping. It was observed that firestopping of pathways within the facility is inconsistently applied or maintained (Photo T-7). NEC Article 300.21, "Openings around electrical penetrations through fire-resistant-rated walls, partitions, floors, or ceilings shall be firestopped using approved methods to maintain the fire-resistance rating."
