**NIOSH**  
Fire Fighter Fatality Investigation  
and Prevention Program

A summary of a NIOSH fire fighter fatality investigation

April 14, 2015

## Two Career Fire Fighters Die in a Rapid Fire Progression While Searching for Tenants—Ohio

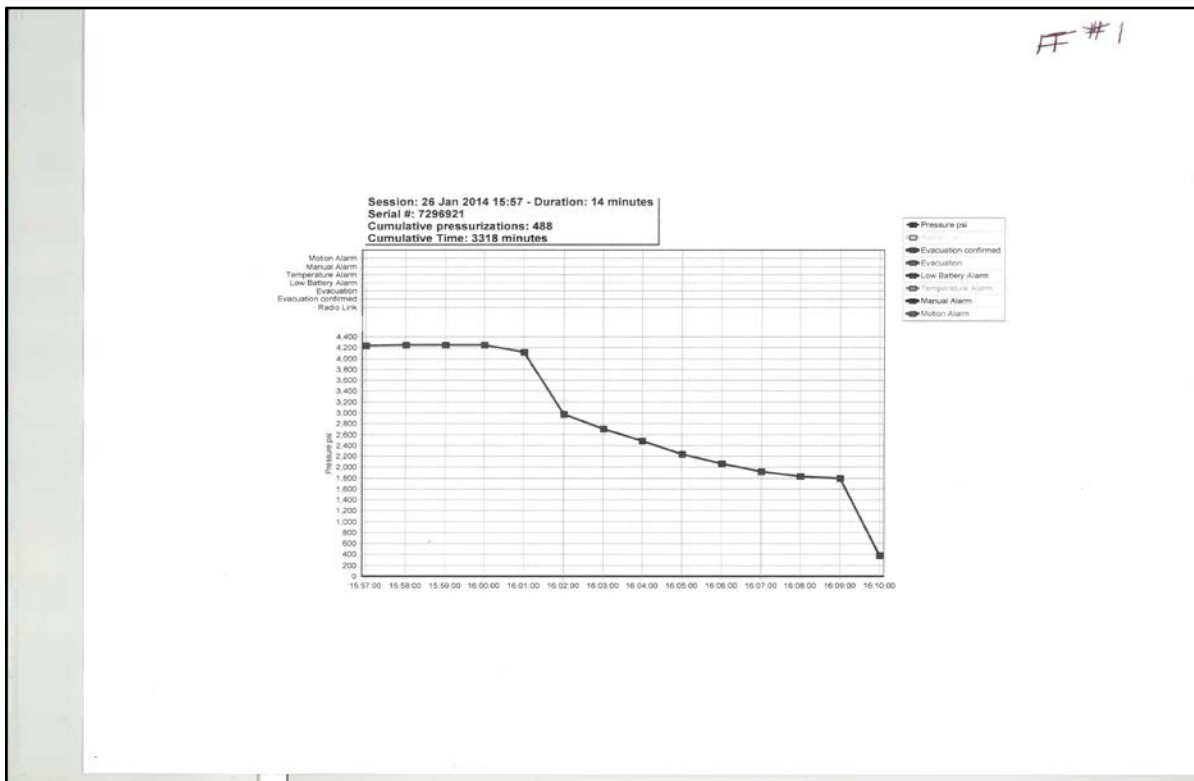
On June 19, 2014, representatives of the Mine Safety Appliances Company (MSA) down loaded the data loggers included with these SCBA units. The data downloads were performed at the MSA facility in Cranberry Township, Pennsylvania and the downloads were witnessed by NIOSH and Fire Department personnel. Attached are the SCBA cylinder pressure versus time charts for both fire fighters. Please note the cylinders were close to full and the duration was 14 minutes and 15 minutes, respectively. Places where the graph indicates a sudden drop in pressure suggests that that the by-pass was used for cool air, the face piece may have dislodged, or the face piece seal was broken by accident or on purpose.
